RICS
HomeBuyer Report

SAMPLE REPORT NOT FOR USE

Property address

Date of inspection 29th March 2016

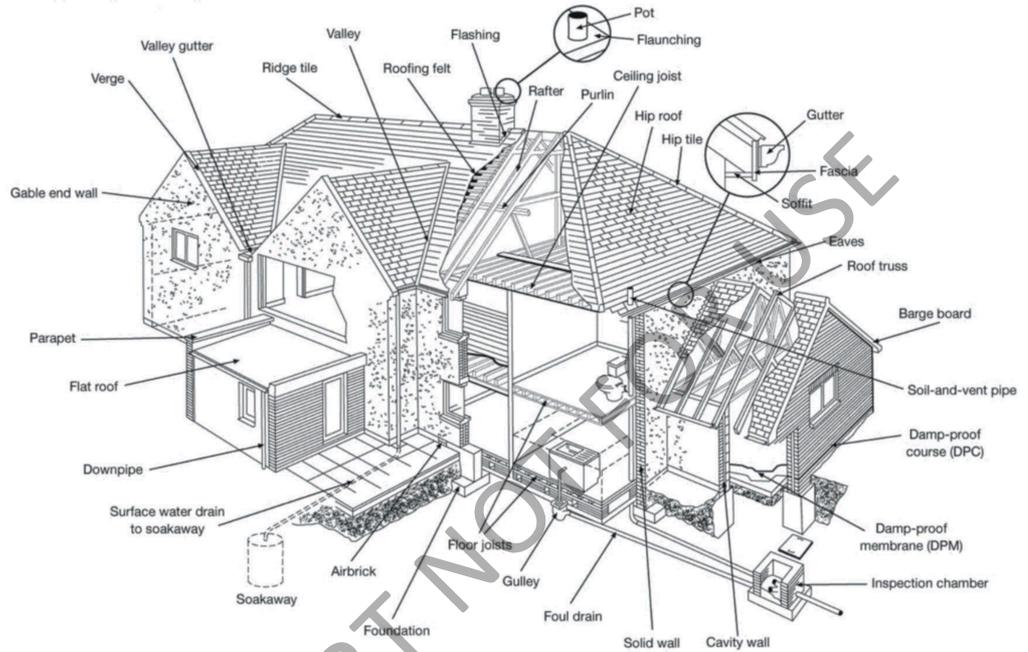
Typical house diagram

This diagram illustrates where you may find some of the building elements referred to in the report.
