RICS
Building Survey

Property address	<input type="text" value="22 Somewhere Street
Leicestershire
XX4 4XX"/>
Clients' name	<input type="text"/>
Date of inspection	<input type="text" value="18th January 2016"/>

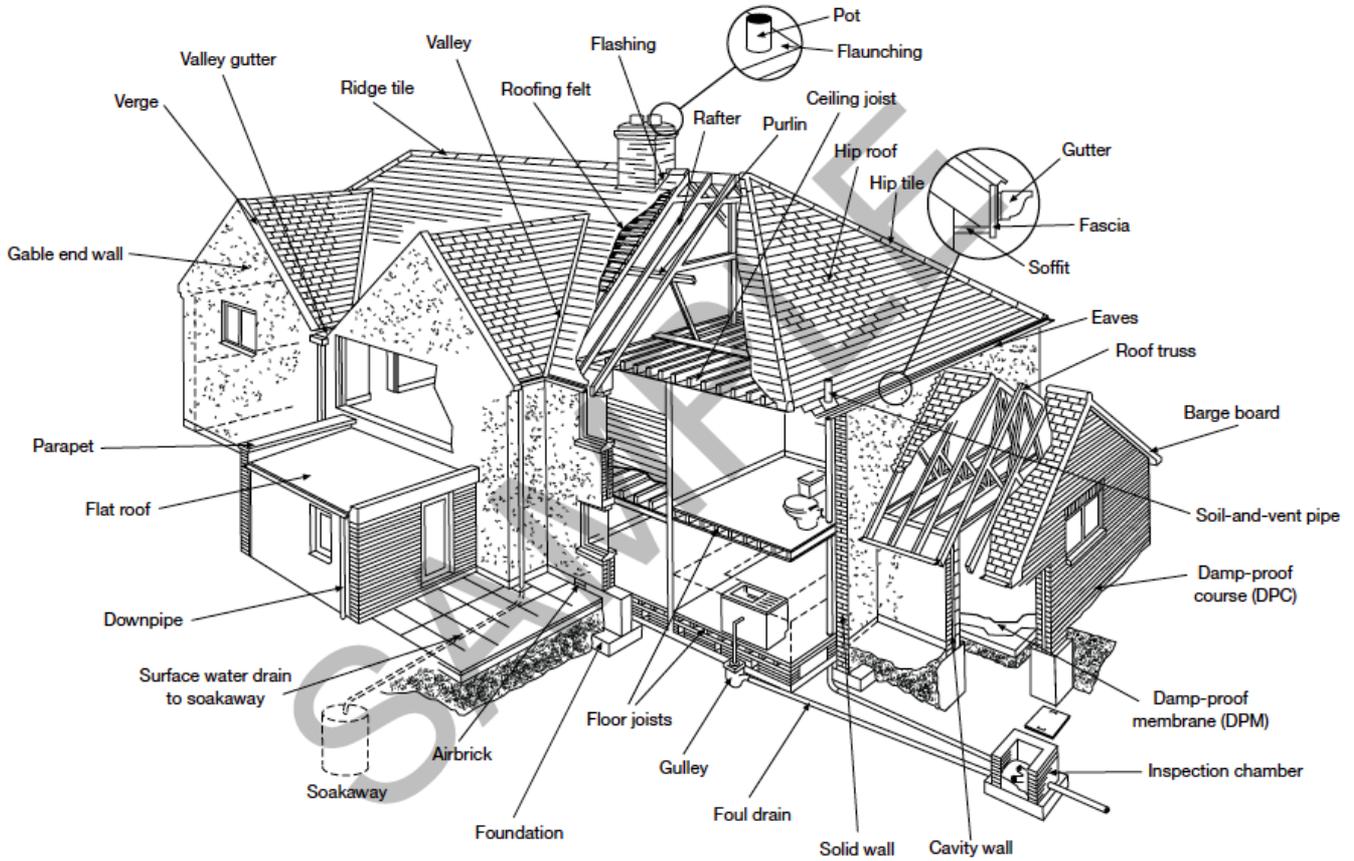
Typical house diagram

This diagram illustrates where you may find some of the building elements referred to in the report.
